Manhole Inspection Summary

Manhole # S47E2_017MH

Record Plat: **47E2** Node: **017** Status: **New Manhole (Not in GIS)** Insp Date: **1/16/08 12:00 AM**

Location Address: **Morrison-grace** Cross Street: **Olmstead-Locust**

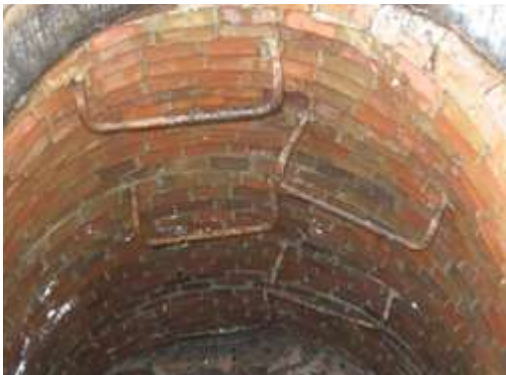
Steps Count: **5** Missing: **0** ☐ Corroded

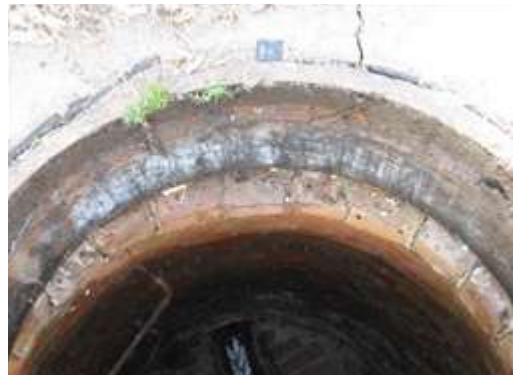
Defect 1

Frame Offset: **2** (in.) Condition: ☒ Sound ☐ Cracked ☐ Leaks

Frame offset

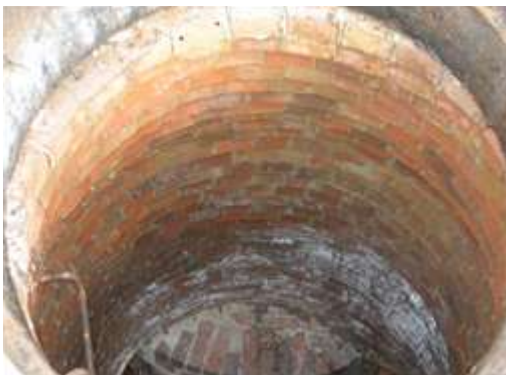
Defect 2

Barrel Material: **Brick** ☐ Parged
Shape: **Circular** Diameter: **42** (in.) Length: (in.)
Condition: ☒ Sound ☐ Cracked ☐ Root Intrusion ☐ Loose Brick ☐ Deteriorated
Infiltration: ☐ None ☐ Joint ☐ Cracks ☐ Mortar ☐ Roots ☒ **Wall**

Wall

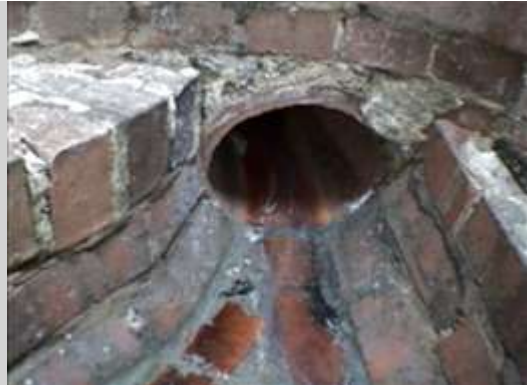
12 O'Clock Outflow

10 in. Circular Gravity Sewer
Pipe Out @ 12 O'Clock

Pipe Height: **9.6** (in.) Rod and Bar (Angled)
Pipe Material: **Clay** ☐ Pipe Lined
Invert Depth: **10.54** (ft.) Flow Characteristics: **Fast**
Deposits: ☒ None ☐ Mud ☐ Sludge ☐ Debris ☐ Grease
Silt Depth: (in.) Deposits Extent:
Infiltration: **None** Pipe Seal Cond: **Sound**

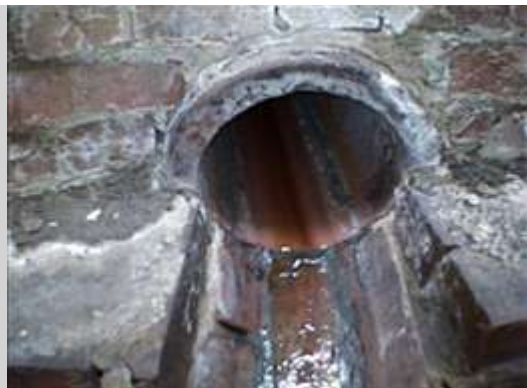
3 O'Clock Inflow

10 in. Circular Gravity Sewer
Pipe In @ 3 O'Clock

Pipe Height: **10.8** (in.) Rod and Bar (Angled)
Pipe Material: **Clay** ☐ Pipe Lined
Invert Depth: **8.09** (ft.) Flow Characteristics: **None**
Deposits: ☒ None ☐ Mud ☐ Sludge ☐ Debris ☐ Grease
Silt Depth: (in.) Deposits Extent:
Infiltration: **None** Pipe Seal Cond: **Sound**

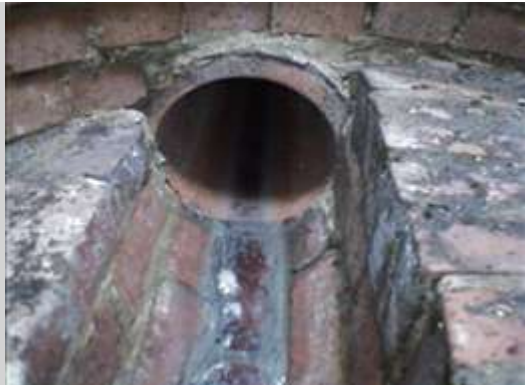
6 O'Clock Inflow

8 in. Circular Gravity Sewer

Pipe In @ 6 O'Clock

Pipe Height: **8.4** (in.) Rod and Bar (Angled)

Pipe Material: **Clay** ☐ Pipe Lined

Invert Depth: **9.10** (ft.) Flow Characteristics: **Fast**

Deposits: ☒ None ☐ Mud ☐ Sludge ☐ Debris ☐ Grease

Infiltration: **None**

Pipe Seal Cond: **Sound**

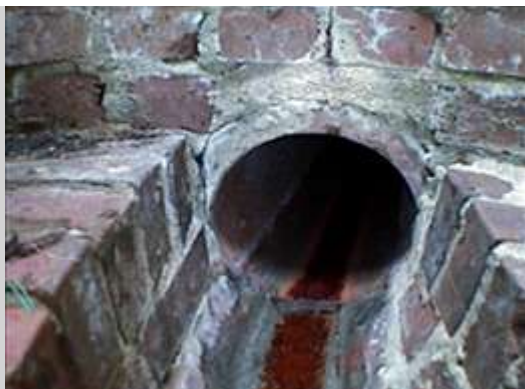
9 O'Clock Inflow

10 in. Circular Gravity Sewer

Pipe In @ 9 O'Clock

Pipe Height: **9.6** (in.) Rod and Bar (Angled)

Pipe Material: **Clay** ☐ Pipe Lined

Invert Depth: **9.12** (ft.) Flow Characteristics: **Slow**

Deposits: ☒ None ☐ Mud ☐ Sludge ☐ Debris ☐ Grease

Infiltration: **None**

Pipe Seal Cond: **Sound**
